Denka

August 20, 2026

Results of Soil Contamination Investigation at Former Ofuna Plant Site

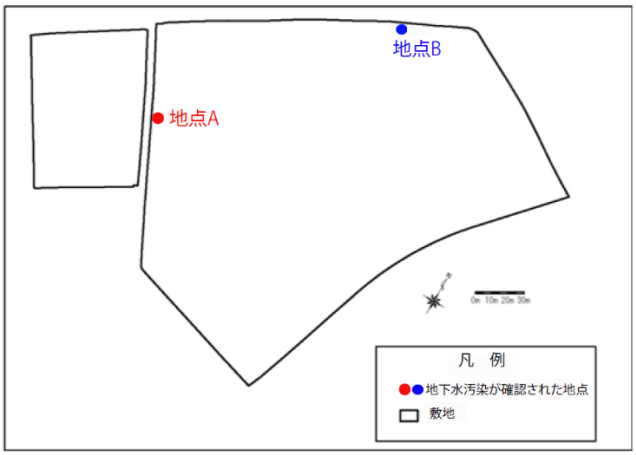
Figure 2: Water Investigation

2. Investigation Results (Figure 2)

Substances exceeding environmental quality standards	Locations exceeding standards	Highest concentration (mg/L)	Regulatory standard (mg/L)	Number of locations exceeding standards
Carbon tetrachloride	Location A Figure 2:●	0.62	0.002 or less	1
Chloroethylene		0.48	0.002 or less	1
1,2-Dichloroethylene		8.8	0.04 or less	1

Dichloromethane		0.034	0.02 or less	1
Tetrachloroethylene		0.034	0.01 or less	1
Trichloroethylene		35	0.01 or less	1
Benzene		14	0.01 or less	1
Cadmium	Location B Figure 2:●	0.015	0.003 or less	1
